Manhole Inspection Summary

Manhole # S19001015MH

Insp Date: **12/3/07 10:43 AM**

Location Address: **TAMARIND RD**

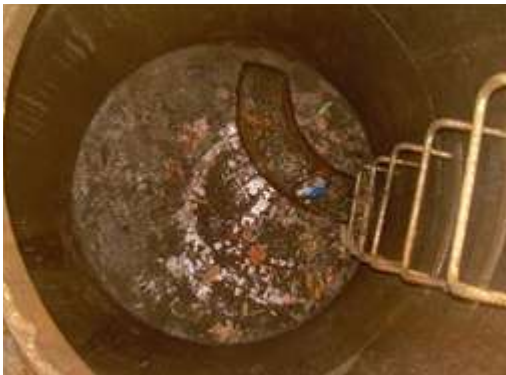
Top View

Bench ☒ Exists Material: **Brick** ☐ Parged ☒ **Debris** (not Condition related)

Channel Material: **Brick** ☐ Parged ☒ **Debris** (not Condition related)

Bench and channel debris

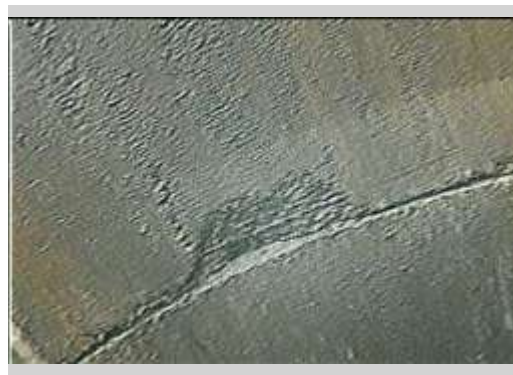
Defect

Cracked barrel

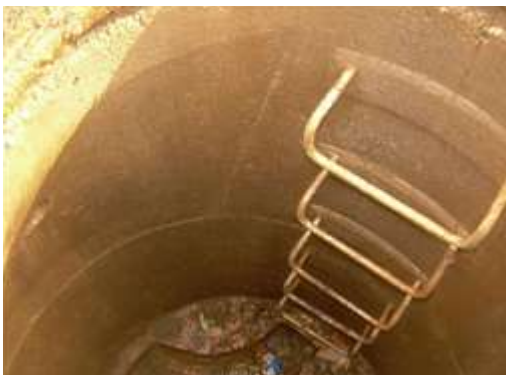
Defect

Infiltration: ☐ None ☐ Joint ☐ Cracks ☐ Mortar ☐ Roots ☒ **Wall**

INFILTRATION IN MH

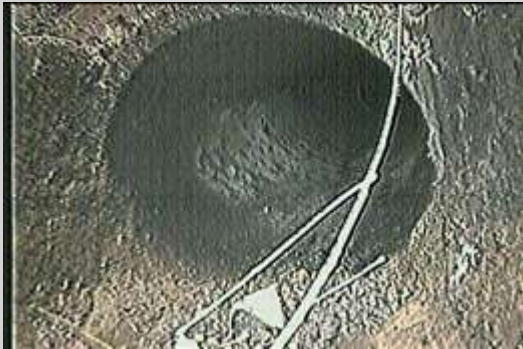
8 in. Circular Gravity Sewer Pipe Out @ 12 O'Clock

Rod and Bar (Angled)

Pipe Material: **Clay** ☐ Pipe Lined

Invert Depth: **7.23** (ft.) Flow Characteristics: **None**

Infiltration: **None**

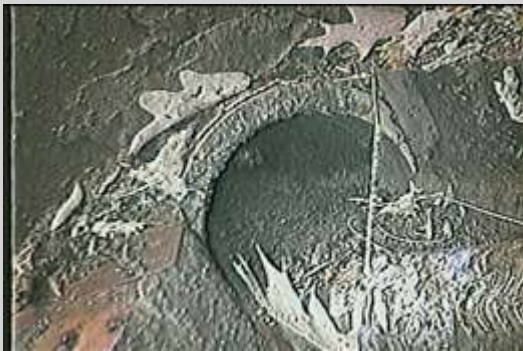
8 in. Circular Gravity Sewer Pipe In @ 6 O'Clock

Rod and Bar (Angled)

Pipe Material: **Clay** ☐ Pipe Lined

Invert Depth: **7.18** (ft.) Flow Characteristics: **None**

Infiltration: **None**
